Report No. FAA-RD-72-25

SONIC BOOM AND NATURAL DETERIORATION EFFECTS ON BUILDINGS: WHITE SANDS, N.M. STRUCTURE RESURVEY

J.H. WIGGINS, JR.

(A SUPPLEMENT REPORT TO REPORTS SST 65-15 (VOLS.
1 AND 2) AND SST 65-18)

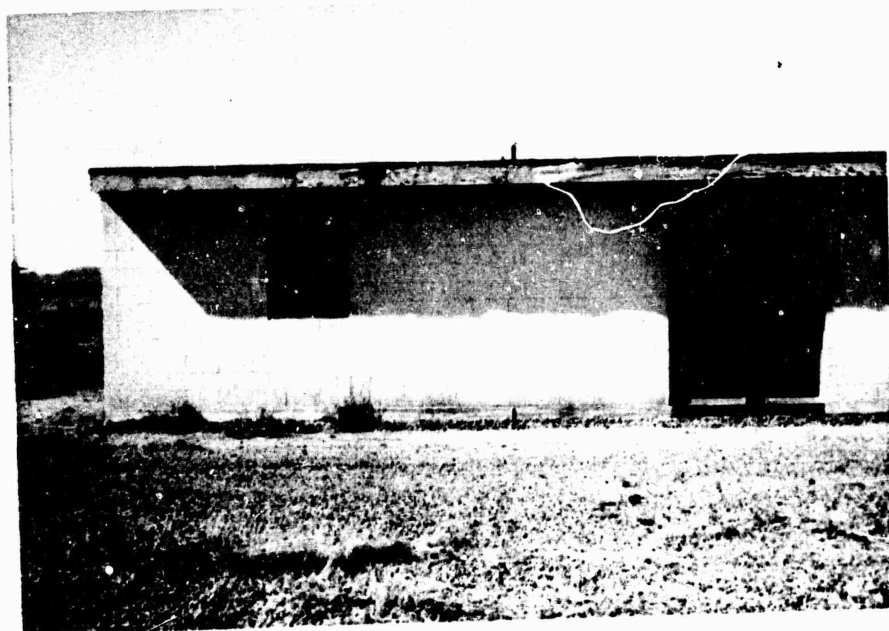
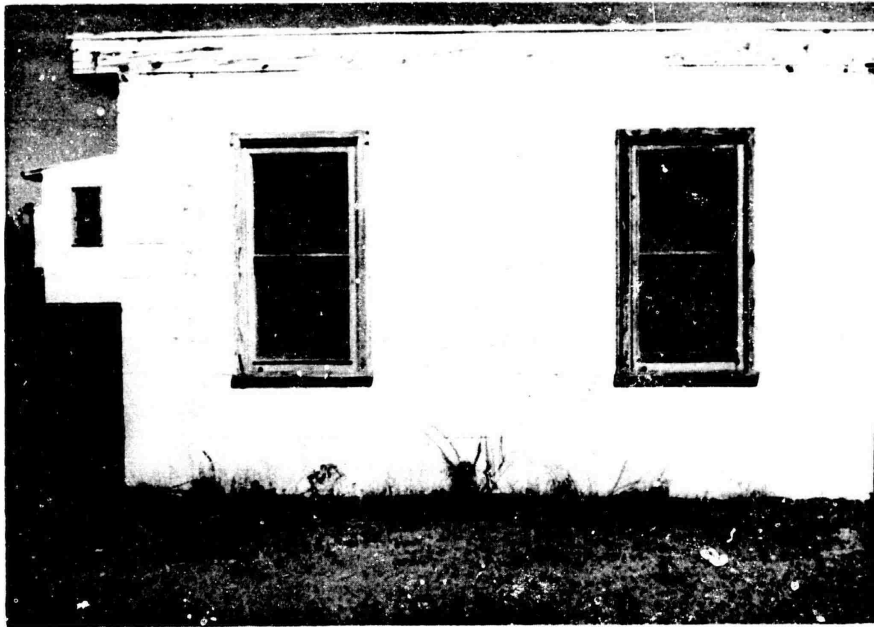
It was noted that no repairs what-so-ever have been made to the buildings since the sonic boom program, however.

Fig. 9 C-1, Northerly exterior

Fig. 10 C-1, Easterly exterior

Fig. 11 C-1, Southerly exterior

Fig. 12 C-1, Westerly exterior

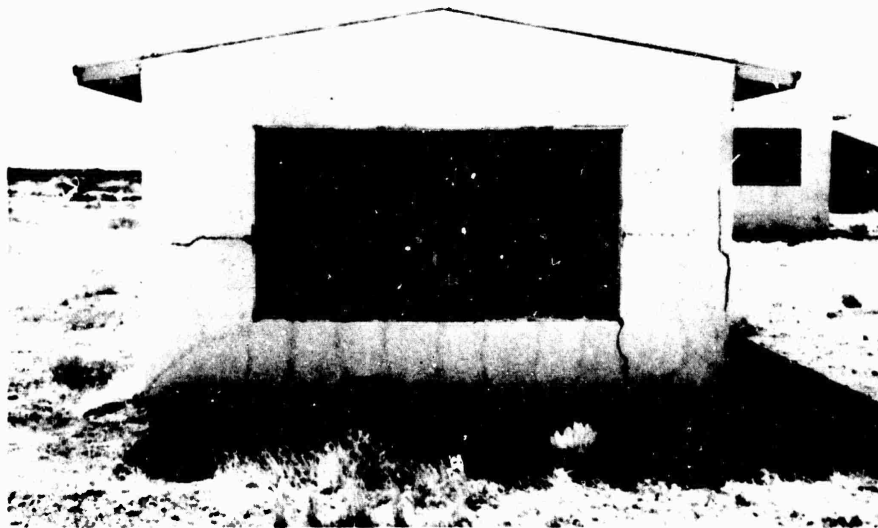
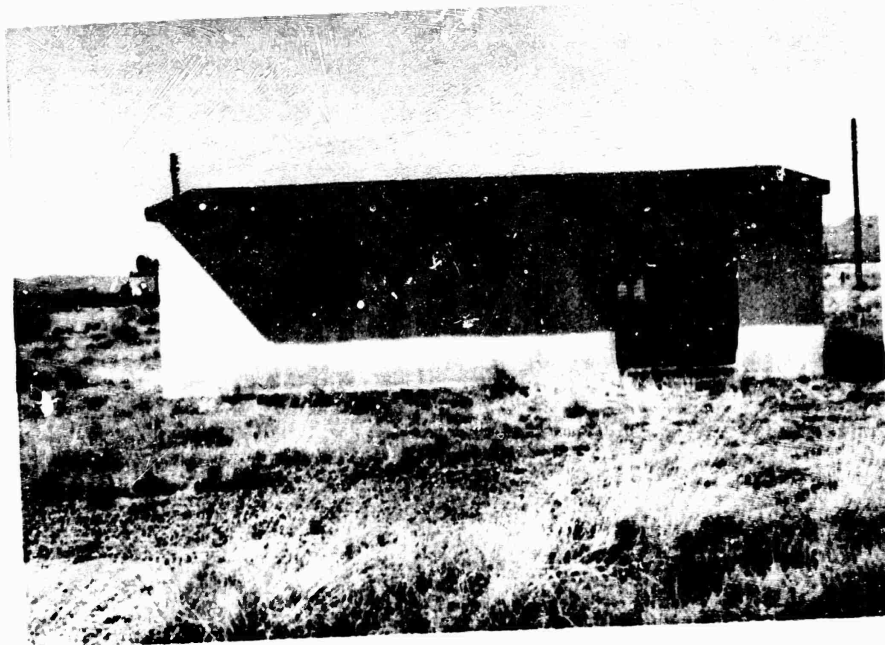
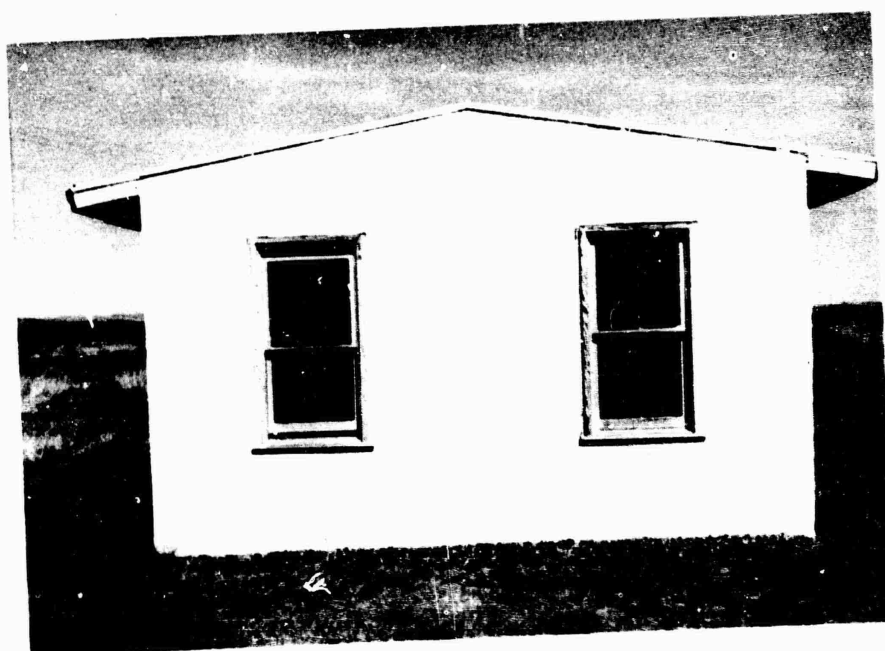
Fig. 14 W-2, Northerly exterior

Fig. 15 W-2, Easterly exterior

Fig. 16 W-2, Southerly exterior

Fig. 17 W-2, Westerly exterior

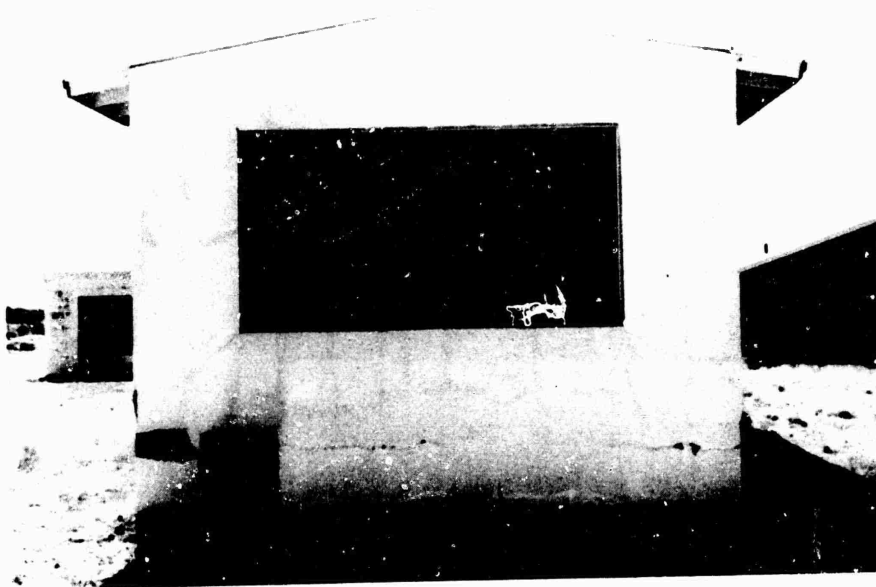
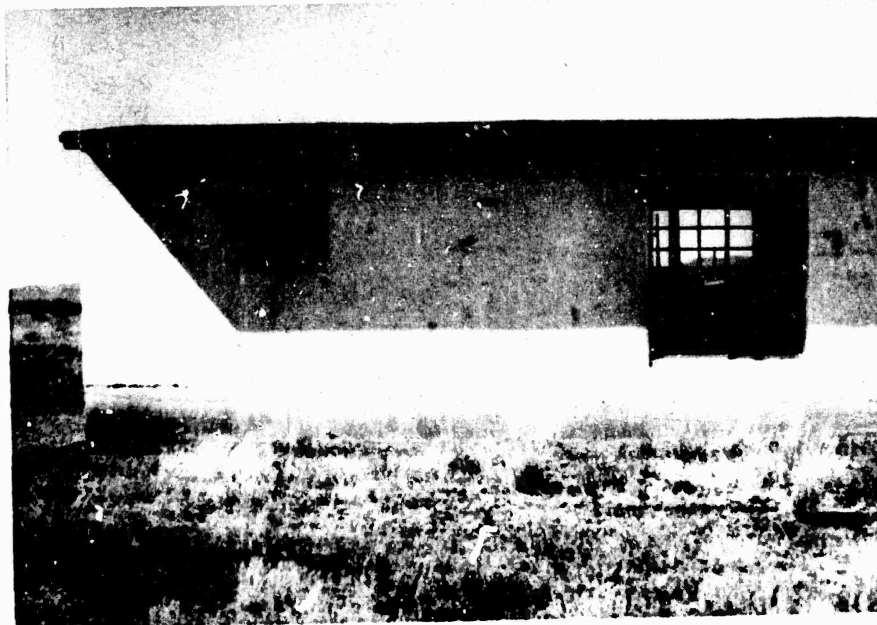
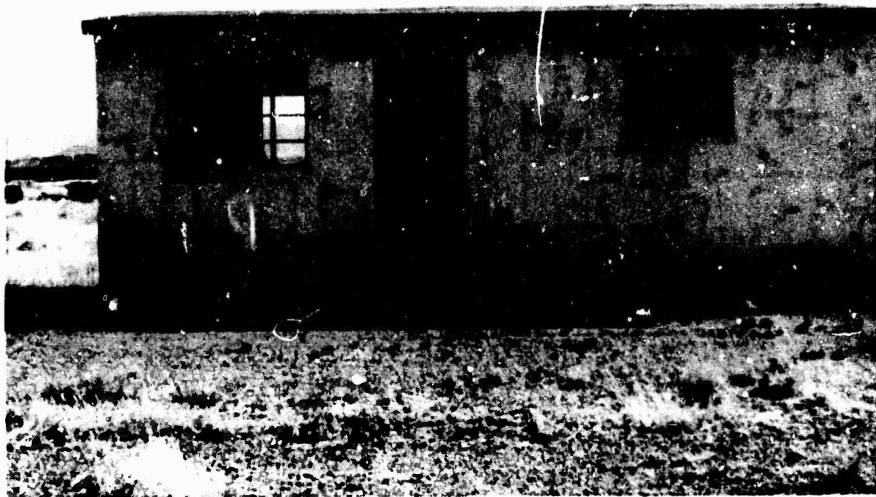
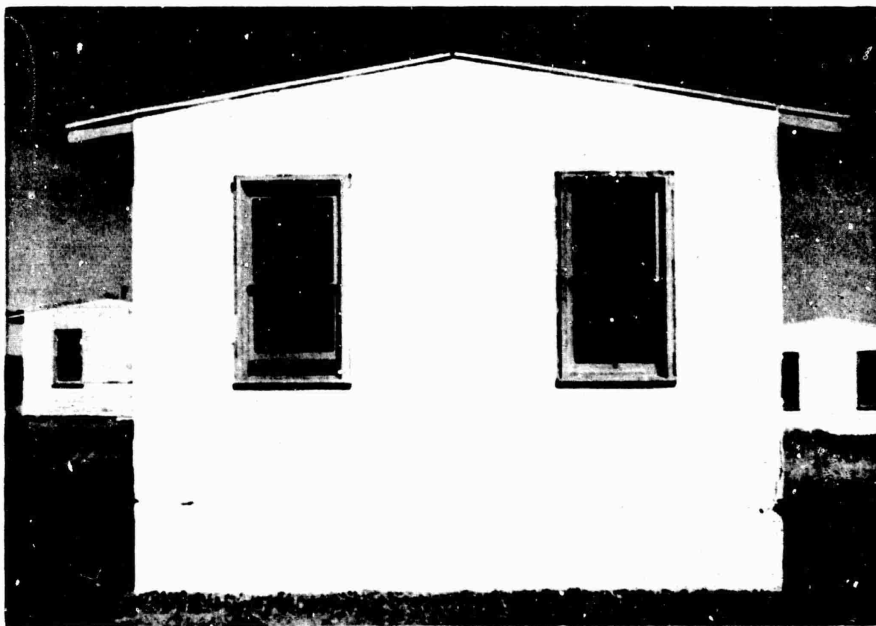
Fig. 21 W-3, Northerly exterior

Fig. 22 W-3, Easterly exterior

Fig. 23 W-3, Westerly Exterior

Fig. 24 W-3, Southerly exterior

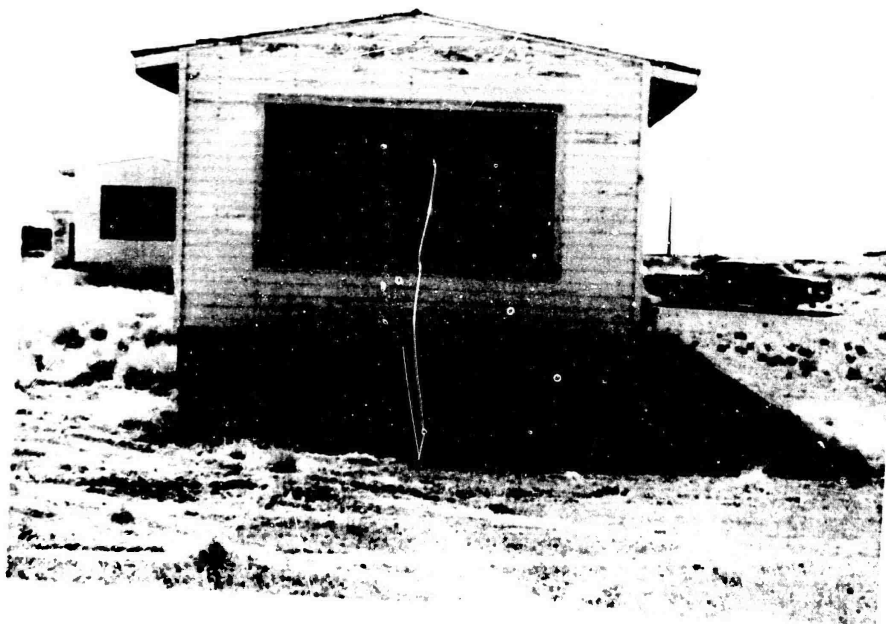
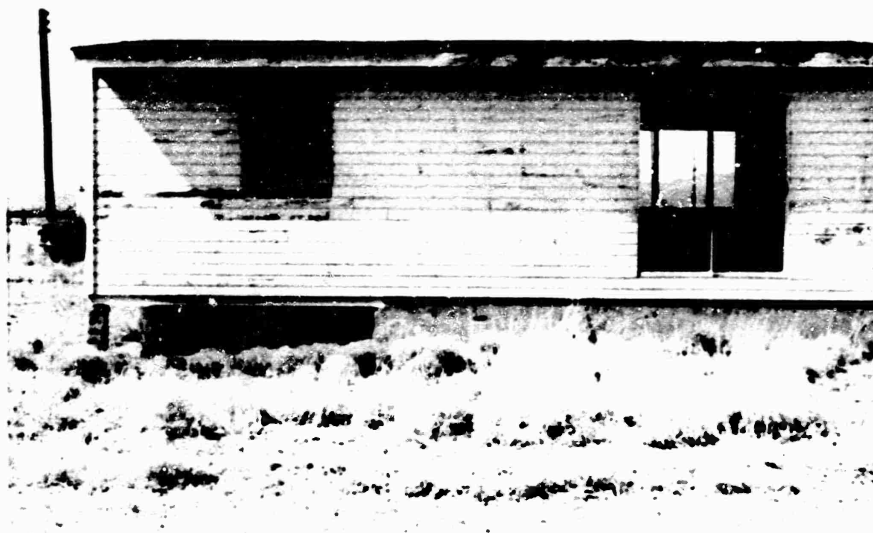
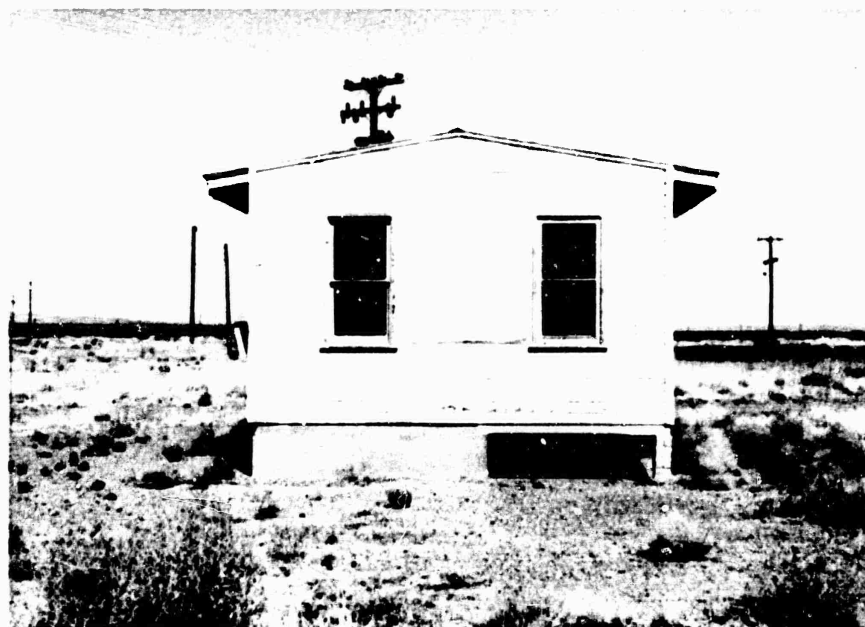
Fig. 28 W-4, Northerly exterior

Fig. 29 W-4, Easterly Exterior

Fig. 30 W-4, Southerly Exterior

Fig. 31 W-4, Westerly Exterior

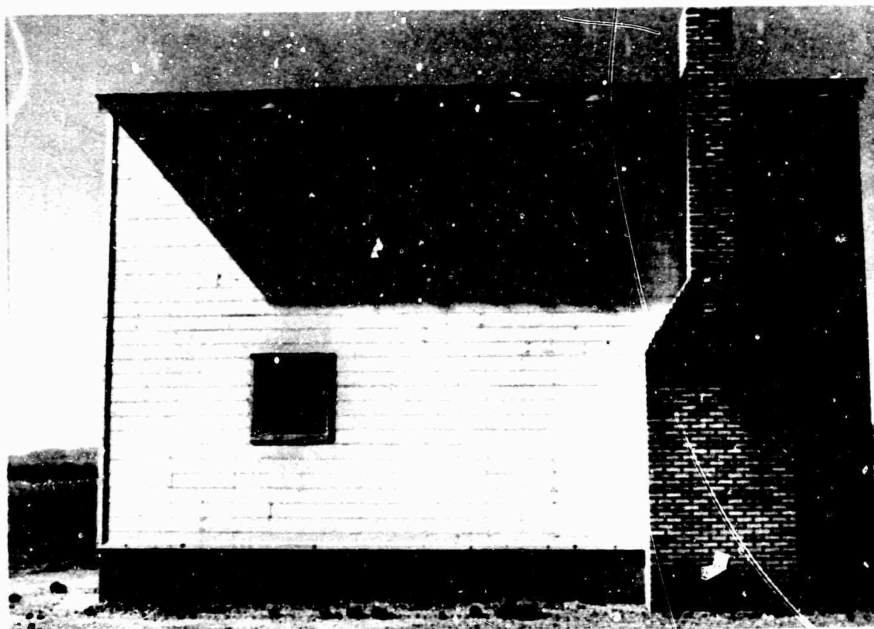
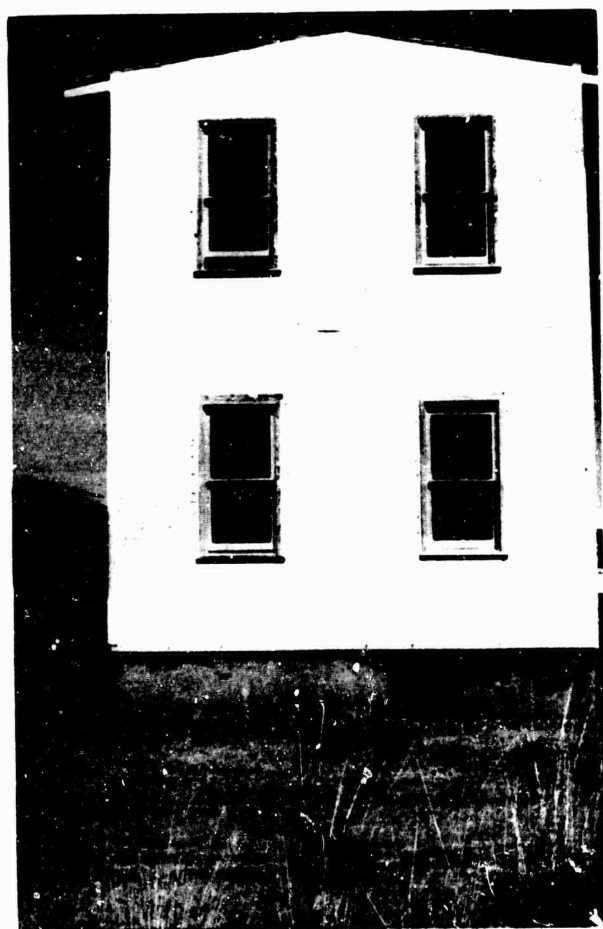
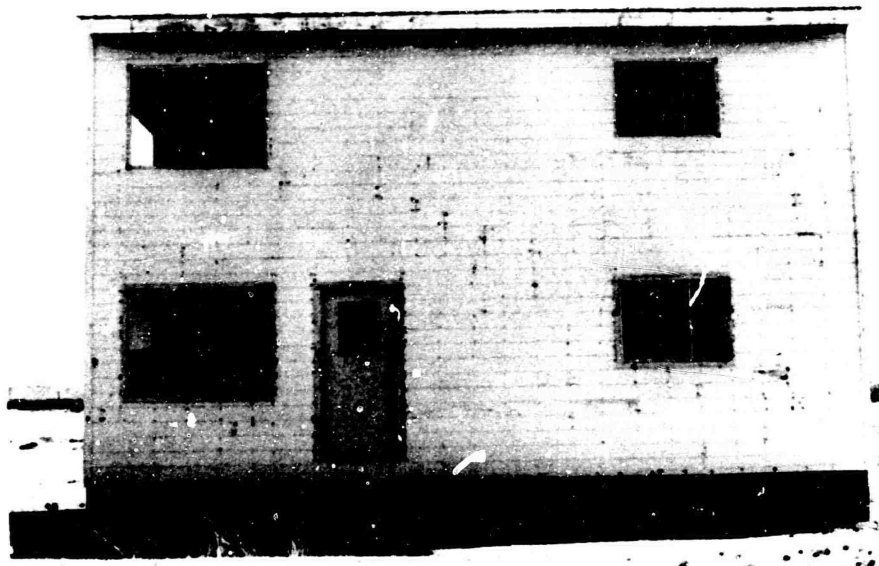
Fig. 35 2S-5, Easterly Exterior

Fig. 36 2S-5, Southerly Exterior

Fig. 37 2S-5, Westerly Exterior

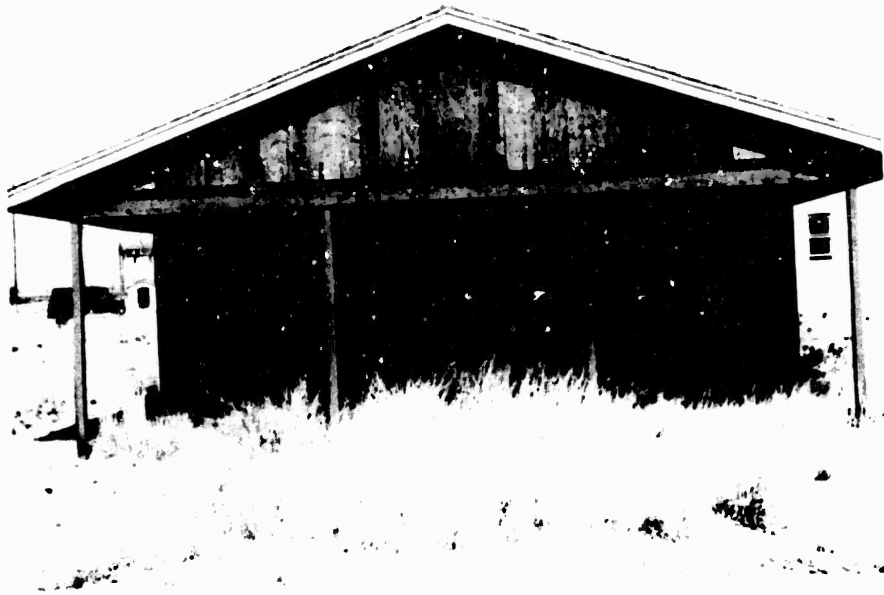
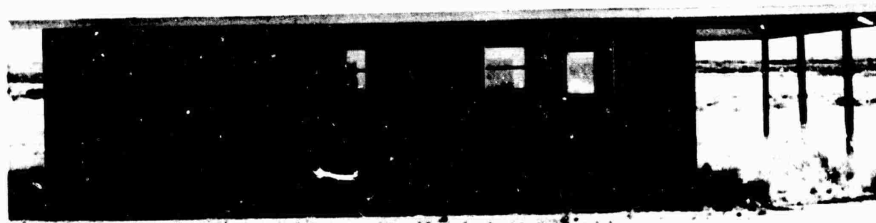
Fig. 41 PF-6, Northerly Exterior

Fig. 42 PF-6, Easterly Exterior

Fig. 43 PF-6, Southerly Exterior

Fig. 44 PF-6, Westerly Exterior
